# Manhole Inspection Summary

Manhole # **S13GG\_056MH**

Insp Date: **2/23/09 2:45 PM**

**Location** Address: **1618 POPLAR GROVE DR**

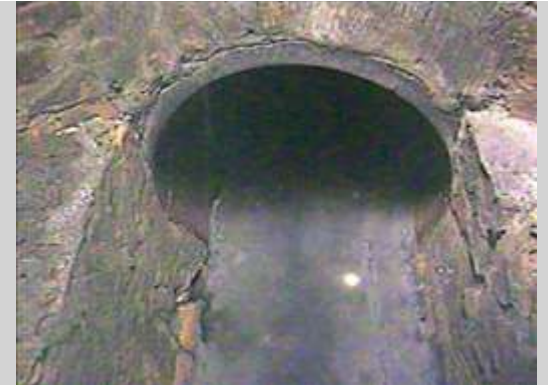
12 O'Clock Outflow

18 in. Circular Gravity Sewer  
Pipe Out @ 12 O'Clock

Pipe Height: **13.2** (in.) Rod and Bar  
Pipe Material: **Clay** ☐ Pipe Lined  
Invert Depth: **8.52** (ft.) Flow Characteristics: **Slow**  
Deposits: ☒ None ☐ Mud ☐ Sludge ☐ Debris ☐ Grease  
Silt Depth: (in.) Deposits Extent:  
Infiltration: **None** Pipe Seal Cond: **Sound**

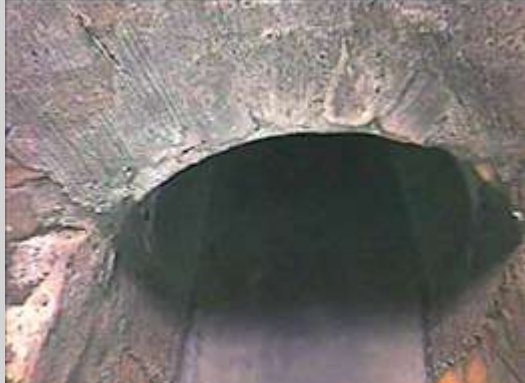
6 O'Clock Inflow

18 in. Circular Gravity Sewer  
Pipe In @ 6 O'Clock

Pipe Height: **12** (in.) Rod and Bar

Infiltration: **None** Pipe Seal Cond: **Sound**
